### National Register of Historic Places Registration Form

### Apartment Buildings on the North End of The Paseo Boulevard in Kansas City, Missouri

The Kessler Apartments
Jackson County, Missouri
Apartment Buildings on the North End of The Paseo Boulevard in Kansas City, Missouri

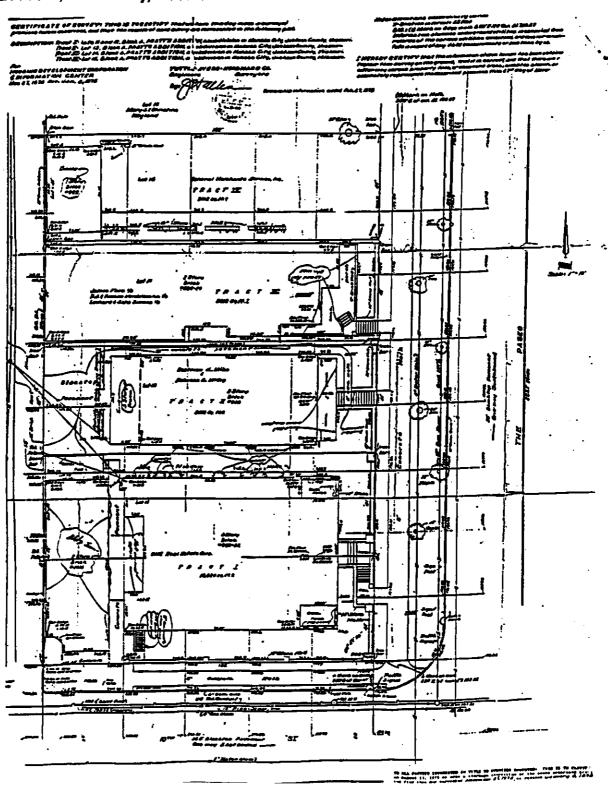
Figure 1: 924 Paseo, 1975 Survey, Tract III

| Figure # | Description |
|---|--|
| 1 | Survey, Tract III |

See Figure 1 - survey

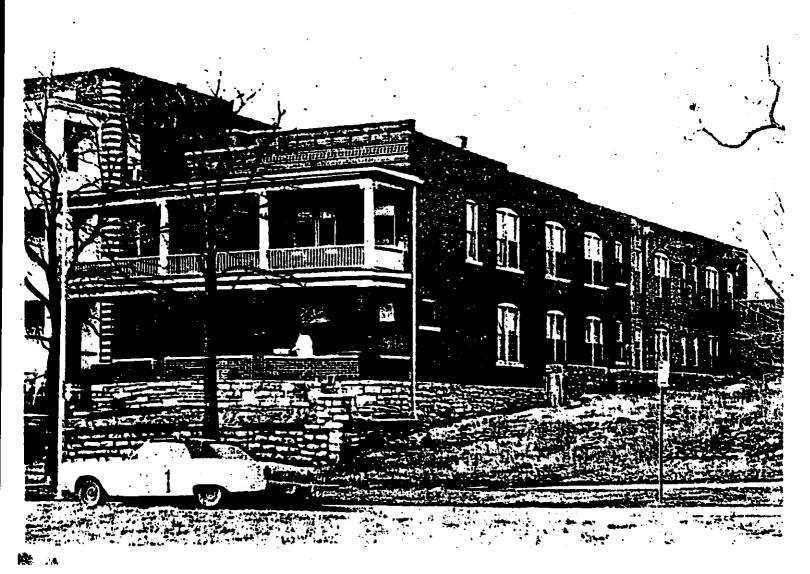
Figure 2. 924 Paseo, Photograph from 1975 Drawings for HUD Remodeling, William Johnson, Architect

| Figure # | Description |
|---|--|
| 2 | Photocopy of 1975 Photo of 924 Paseo |

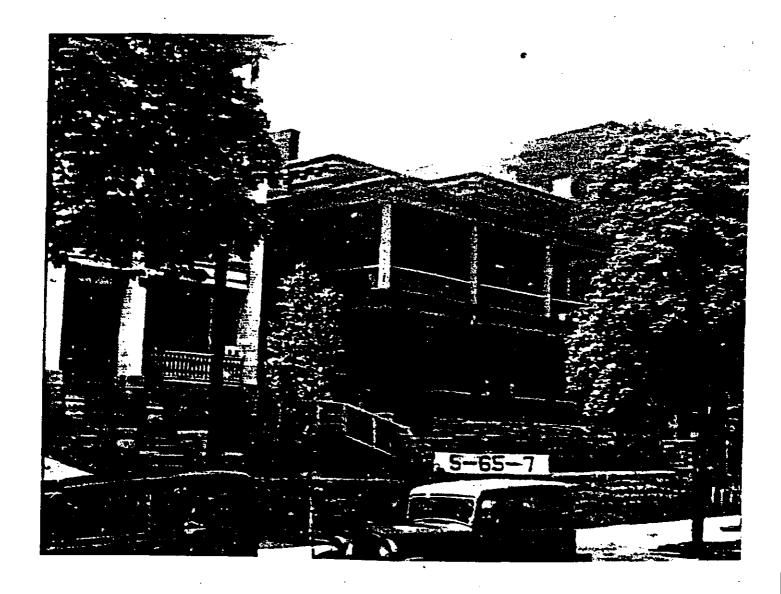
Figure 3, 1940 Tax Assessor's Photo, Landmark's Commission of Kansas City, Missouri

| Figure # | Description |
|---|--|
| 3 | 1940 Tax Assessor's Photo of 924 Paseo |
